# **EXTERNAL FINISH CONSERVATION REPORT**

## **Addendum to the Restoration Method Statement**

**Location:** 1st Hamrun Scout Group, Triq Il-Ferrovija, Hamrun

**Project:** Restoration of Old Hamrun Central Railway Station, including conservation of facades of the Station Building, conservation and repair of the Station Building canopy, new pavement surrounding the Station Building, re-establishing back an entrance door on the western facade of the Station Building from an existing window, Opening up a new door in the boundary wall, next to the entrance gate.

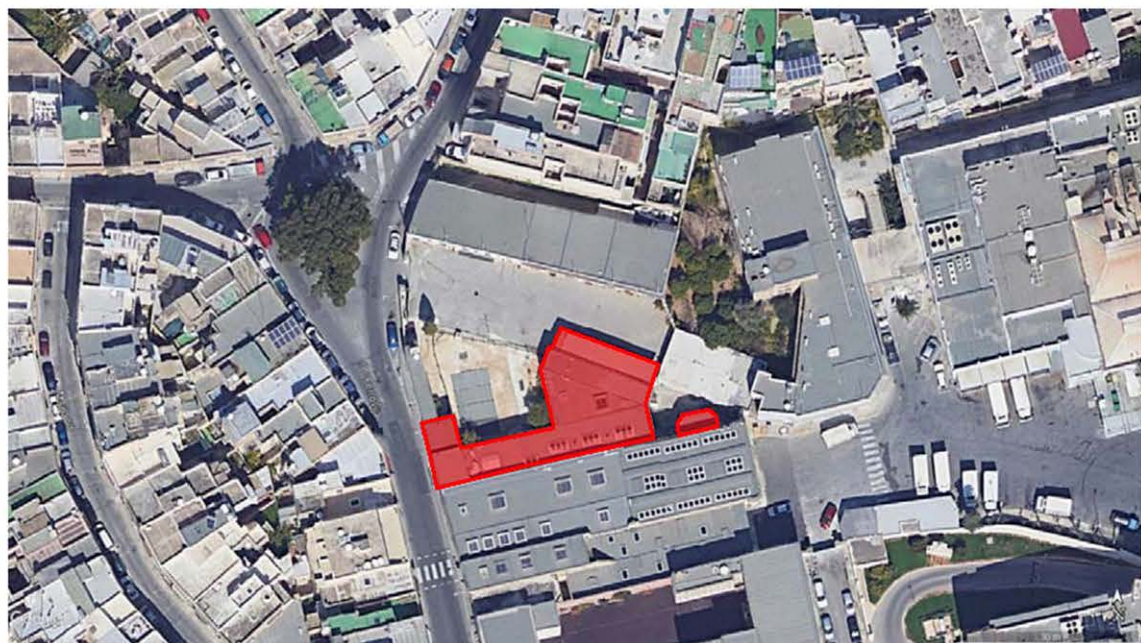
Our firm, Bezzina & Cole, Architects and Civil Engineers, has been commissioned to prepare an External Finish Conservation Report which explains the proposed external finishes to be implemented to the previously painted surfaces of the Old Hamrun Central Railway Station, located at Triq Il-Ferrovija, Hamrun. The exact location of the building is indicated in red in Figure 1 below.

**Figure 1: Site Plan with Station Building marked in red.**

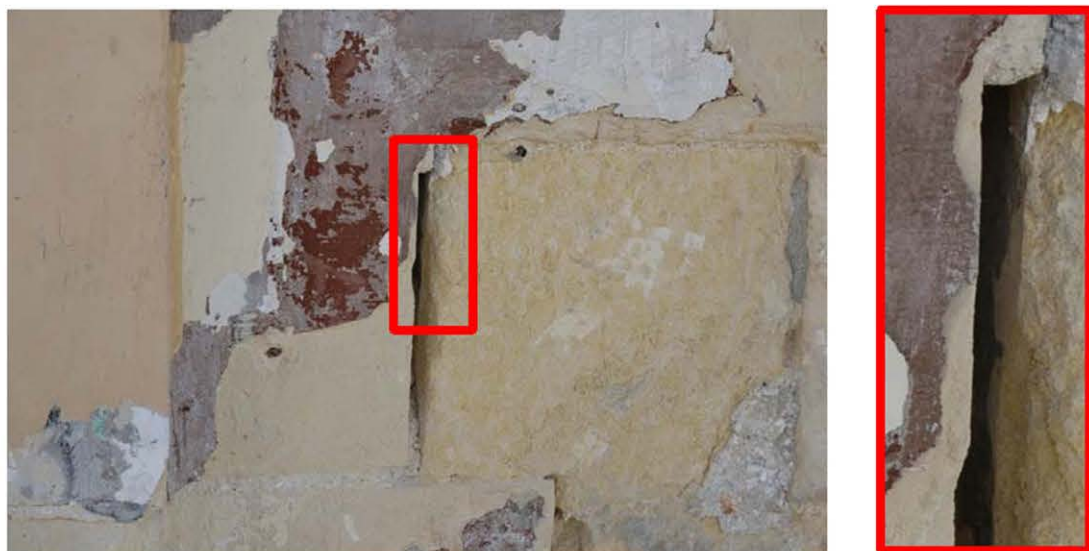
The 1882 Station Building was all painted with Dark (Olive) Green oil paint (vide Figure 3 below). Noteworthy is the fact that the Dark (Olive) Green paint was also applied to the walls and apertures.

**Figure 3: Photo of the exposed construction joint of the extension of the 1882 Station building. Inset photo shows the 1882 Dark (olive) Green oil paint still preserved.**

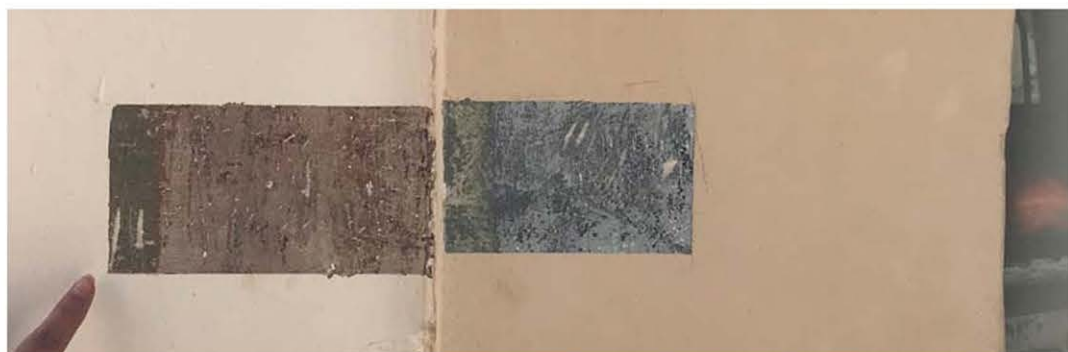
This Colour scheme was also kept during the period when in 1904 the Station Building was extended (vide Figure 4 below).

**Figure 4: Photo of paint stratigraphy of 1904 extension showing the Dark (Olive) Green Colour as the base colour for the whole façade.**

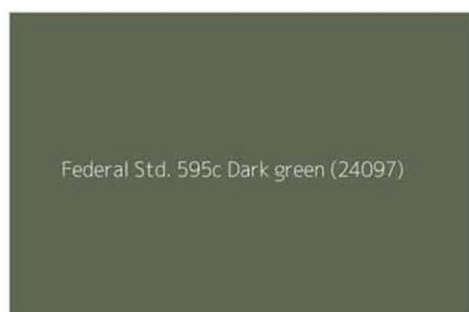
The Dark (olive) Green colour matches the Dark (Olive) Green colour scheme used for the trains; Dark olive Green (Federal Standard 595a colour code 24097(6) / Methuen colour code 30/F/4) (Bonnici & Cassar, 1992 pg. 145) which colour is reproduced in Figure 5 below.

**Figure 5: Train Colour Scheme based on Bonnici & Cassar, 1992.**

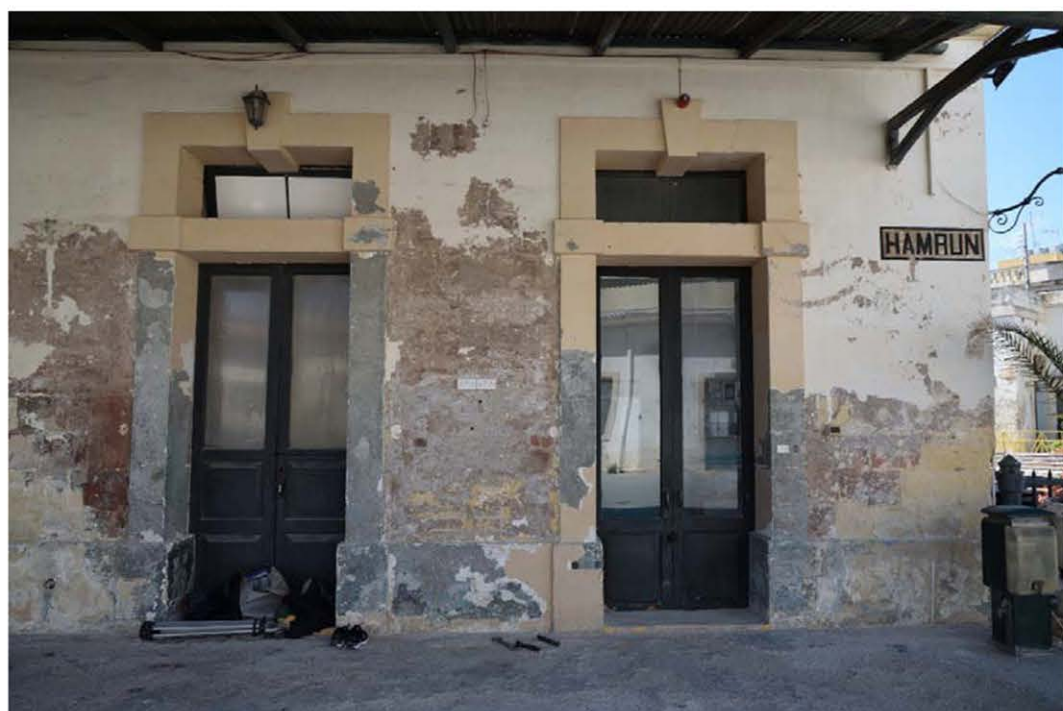
This Colour scheme of the station building uses two main colour hues (vide Figure 6) compared to the previous colour scheme which uses only one hue, this being Dark (Olive) Green. This change in colour scheme came about during that epoch, when in Malta, it was customary and popular to paint important buildings in red, this colour being reminiscent of the red brick buildings in Britain. Notwithstanding, the building was not painted all in red. The Earthy Red was used for the plain surfaces of the walls, the Dark (Olive) Green was used for the apertures and canopy structure, while Dark Cyan (Blue), which later on was changed to Greenish Grey, were used for the wall decorative surfaces (base, frame and cornice).

**Figure 6: Photo of the Station Building Main Façade with the Earthy Red, Dark (Olive) Green / Dark Cyan (Blue) colour scheme as exposed on site.**

It is recommended that, the Station Building is painted using a water thinned alkyd resin paint system adopting a colour scheme consisting of an Earthy Red, Dark (Olive) Green / Dark Cyan (Blue) / Greenish Grey colours. The reasons for the latter mentioned are the following:

- The Station Building, in its current form, was the result of the 1904 expansion, which, for the longest period, was painted in Earthy Red, Dark (Olive) Green / Dark Cyan (Blue) / Greenish Grey colour.
- The colour scheme is associated with the Railway colour brand Insigna red/Dark Green.
- This colour scheme was the latest one applied to the building, when serving as a railway station,
- It also seems that this colour scheme survived right up to post 1968, when the 1<sup>st</sup> Hamrun Scout Group started to use the Old Hamrun Railway Station as their Headquarters.
- This proposed colour scheme is so also associated with living memory of the place.
- Water thinned alkyd resin paint system is visually similar and compatible with the existing oil paint.

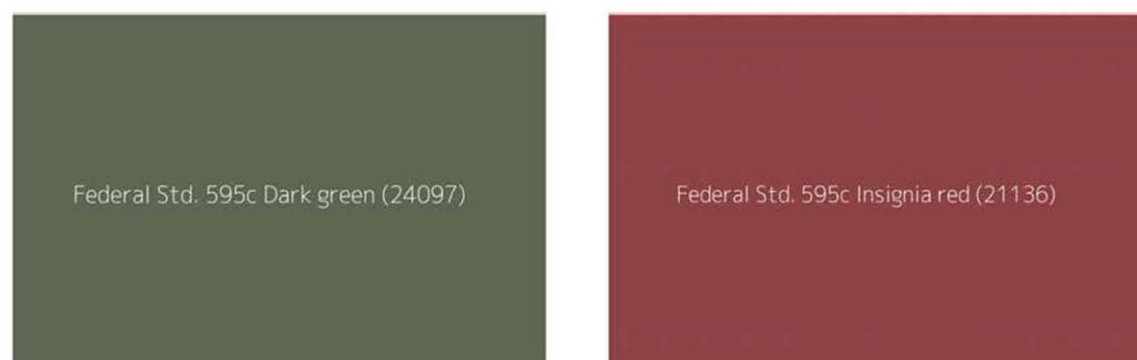
On closer observation, it becomes apparent that, the dark (olive) green, dark cyan, and greenish grey colours, can be considered as hues of green, and it could be that both colours were intended to represent the dark (olive) green. The colour of the wall decorative surfaces was slightly modified on two instances, so as to distinguish them from the apertures and canopy structure. The colour combination of Earthy Red, Dark (Olive) Green / Dark Cyan (Blue) / Greenish Grey also matches the colour scheme used for the trains, Dark olive Green (Federal Standard 595a colour code 24097(6) / Methuen colour code 30/F/4) and Dark red (Federal Standard 595a colour code 21136 / Methuen colour code 10/D/8) (Bonnici & Cassar, 1992 pg. 145) which colours are reproduced in Figure 7 below.

**Figure 7: Train Colour Scheme based on Bonnici & Cassar, 1992**

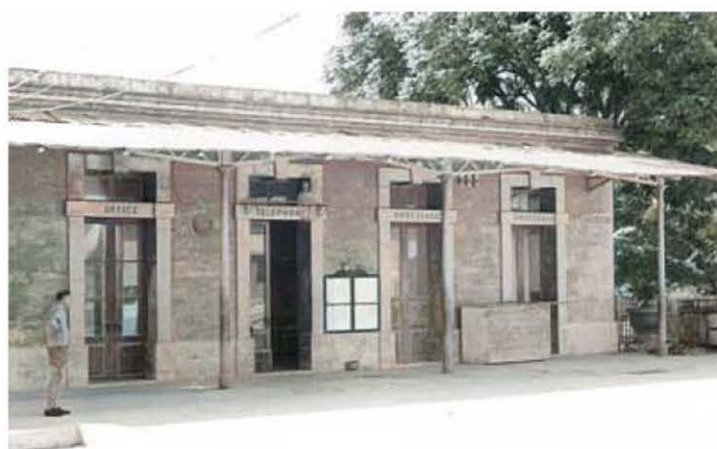
After the closure of Malta Railway in 1931, the Earthy Red, Dark (Olive) Green / Greenish Grey (Blue) colour scheme was retained, and most probably not even repainted. When in 1968, the Old Hamrun Central Railway Station started to be used as the 1<sup>st</sup> Hamrun Scout Group Headquarters, this colour scheme was still present, as indicated in the colourised photograph, Figure 8 below. This was also corroborated from anecdotal information relayed by old scout members.

**Figure 8: Colourised image of post 1950's photo of the Station Building.**

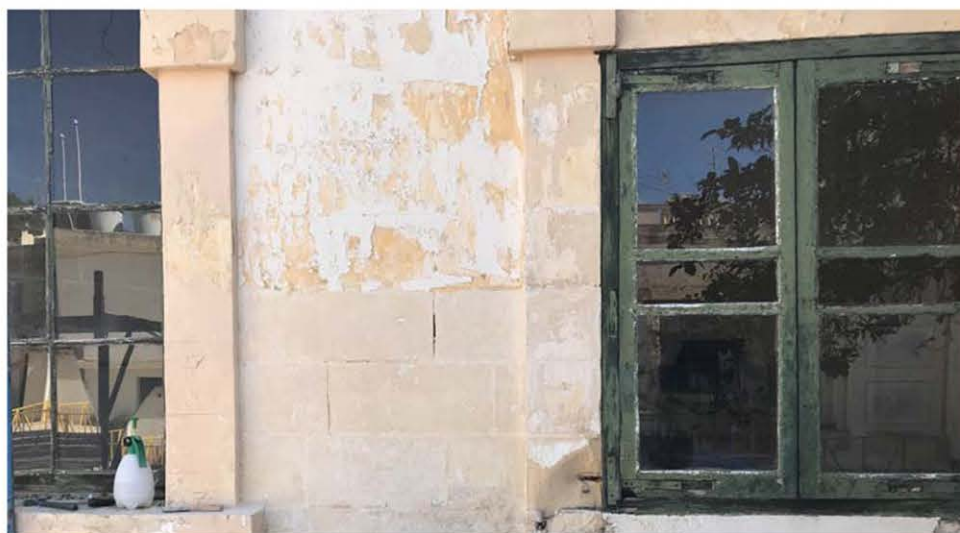
From site investigations it transpired that, the original surface of the 1904 extension was intended to be natural stone ashlar (vide Figure 10 below). At some point in time, it was painted over with a limewash, yellowish in colour more like a stone colour. Over the limewash, different layers of White/beige colour scheme using acrylic paints, were identified.

**Figure 10: Photo of stratigraphy of external finish of 1904 Station/Workshop North Extension next to the door converted into a window.**

The Natural Stone Ashlar finish for the above-mentioned façades is being recommended for the following reasons:

- The external surface finish of the facades when used as a Railway station, consisted of natural Stone Ashlar
- The paint layers and renders of these facades have no architectural or historical significance.

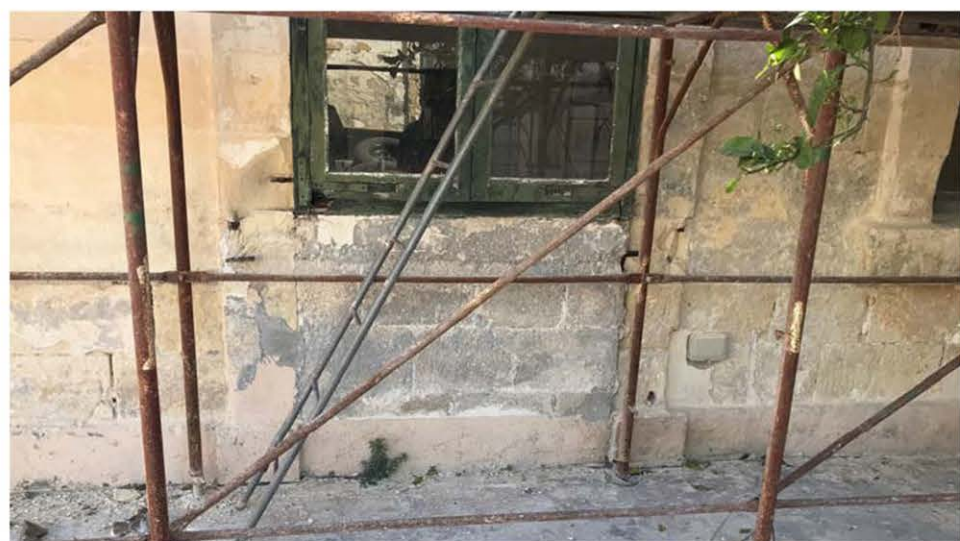
Noteworthy is the fact that the first paint layer consists of a limewash rather than oil-based paint as in the case of the Station Building (Façade Group 3). Furthermore, the colour does not follow any colours associated with the Railway. This makes it difficult to date when the limewash was applied, however it is highly likely that it was applied post 1931, when the door facing the pool, was altered into a window (vide Figure 11) and the northern windows facing the pool were all blocked off (vide Figure 12).

**Figure 11: Photo of wall constructed to change the door into window,**

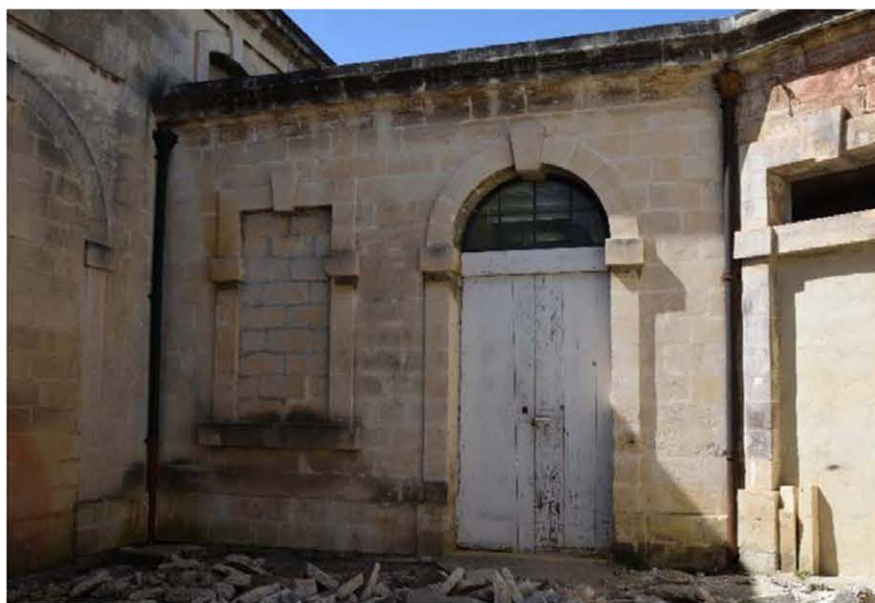
Unfortunately, the 1904 Workshop North extension was cleaned in recent times, thus eliminating any trace of paint layers (vide Figure 13). During the site investigation, no traces of paint were found, not even in the crevasses.

**Figure 13: Photo of the 1904 Workshop North extension façade.**

However, given that the room behind this façade is similar to the 1904 Station/Workshop North Extension (Façade Group 4), it is highly probable that even the façade under consideration consisted of natural stone ashlar, and it was painted, only after the closure of the Railway station, in 1931.

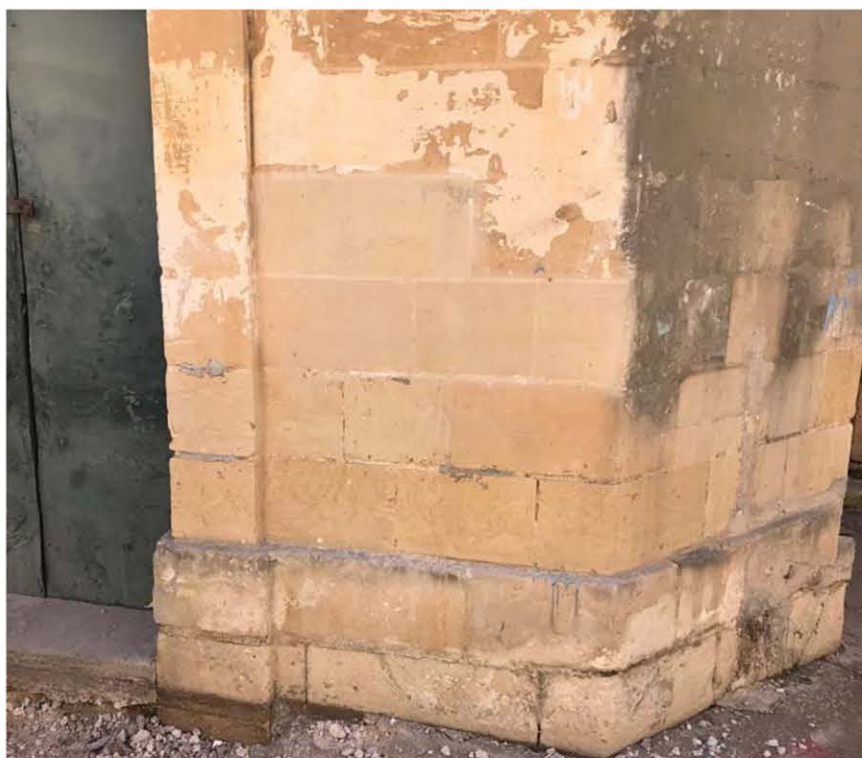
On the facades of the 1904 Ancillary room (Façade Group 1), only patches of whitewash were traced, this having been applied over a natural stone ashlar surface which had already formed a patina. Additionally, when the existing pavement was removed, no traces of whitewash or paint were encountered (vide Figure 16 below).

**Figure 16: Photo of stratigraphy of paint layers of Pre 1897 Workshop, 1904 Ancillary room**

Thus, the surface finish of the façade under consideration consisted of Natural Stone Ashlar. The whitewash seems to have been introduced after the railway closure, when the surrounding pavement level was altered and the damp proof course of the facade was bridged over, resulting in deterioration of the lower courses of the façade.
